DuPont global PV reliability

2019 Field analysis

Executive summary

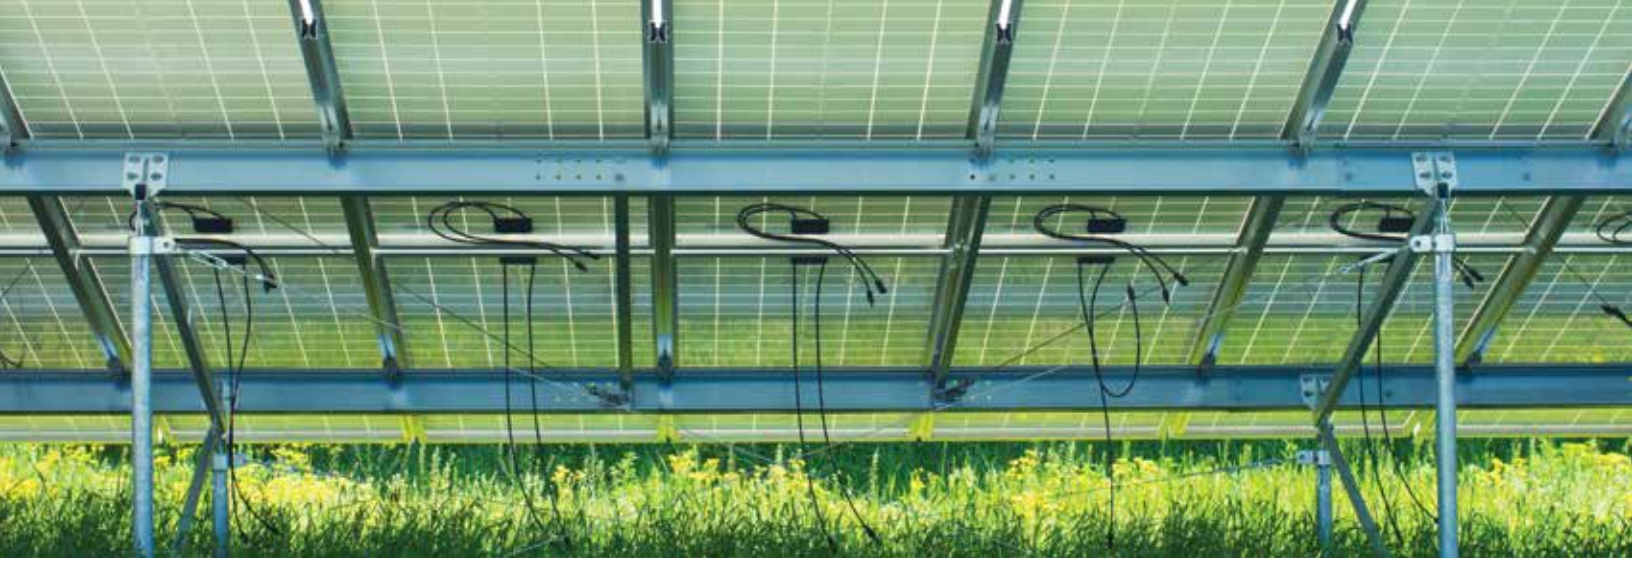
PVDF backsheet failures

Outer-layer cracking

- Widespread cracks allow for delamination, directly exposing the core layer to the environment

Inner-layer yellowing

- Yellowing can be an early sign of material degradation and embrittlement

Outer-layer cracks
6 years, NW China

Outer-layer microcracks
2.5 years, Northern China

Outer-layer cracks
7 years, SW USA

Outer-layer cracks and delamination
6 years, Canada

Inner-layer yellowing
6 years, SW USA

Inner-layer yellowing
6 years, NW China

Inner-layer yellowing
7.5 years, Italy

Inner-layer yellowing
5 years, NW India

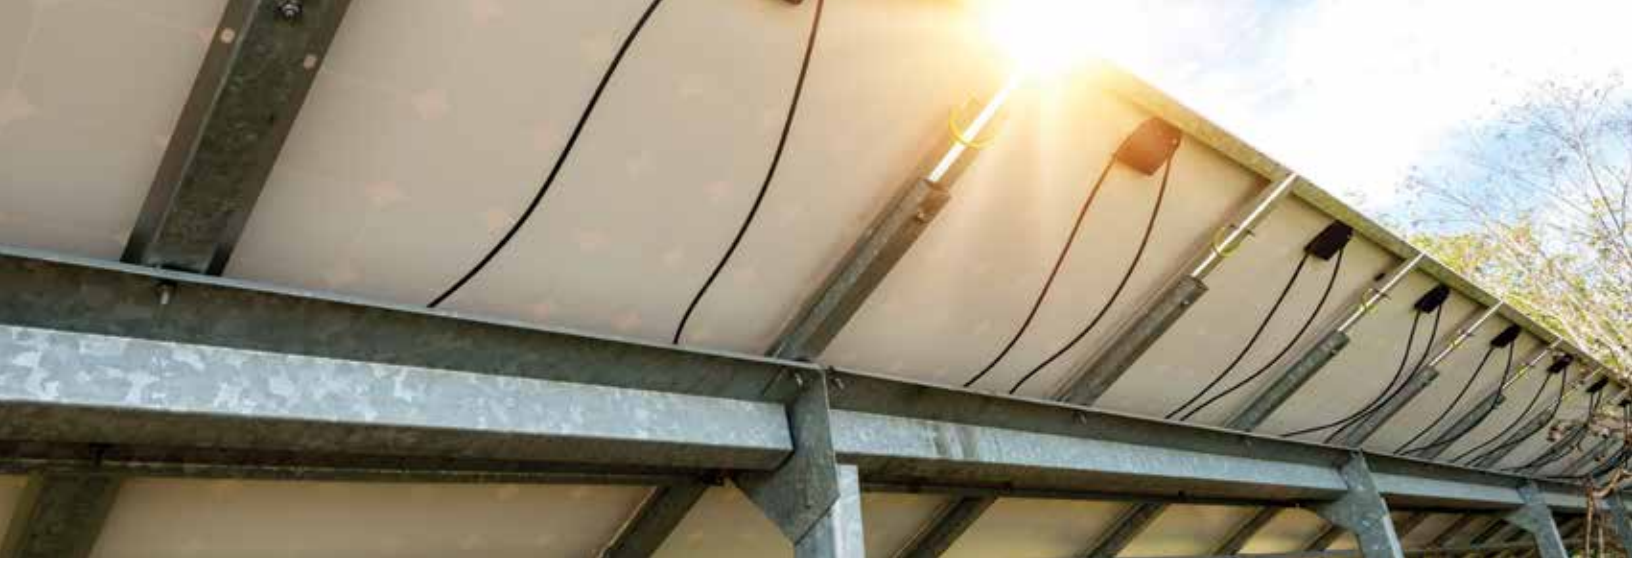
Polyamide backsheet failures

Widespread backsheet through-cracks

- These failures are prevalent along busbar ribbons, but with continued weathering can extend to cell gaps and other regions
- Arcing and shorts often lead to localized burn-through and sometimes full module fires
- Reported inverter tripping and ground faults
- Over 12 GW of field failures to date

Outer-layer cracks
6 years, NW China

Inner-layer cracks
6 years,
Sonoran Desert, USA

Burn-through
7 years,
Sonoran Desert, USA

Burn-through
6 years, High Desert,
Nevada, USA

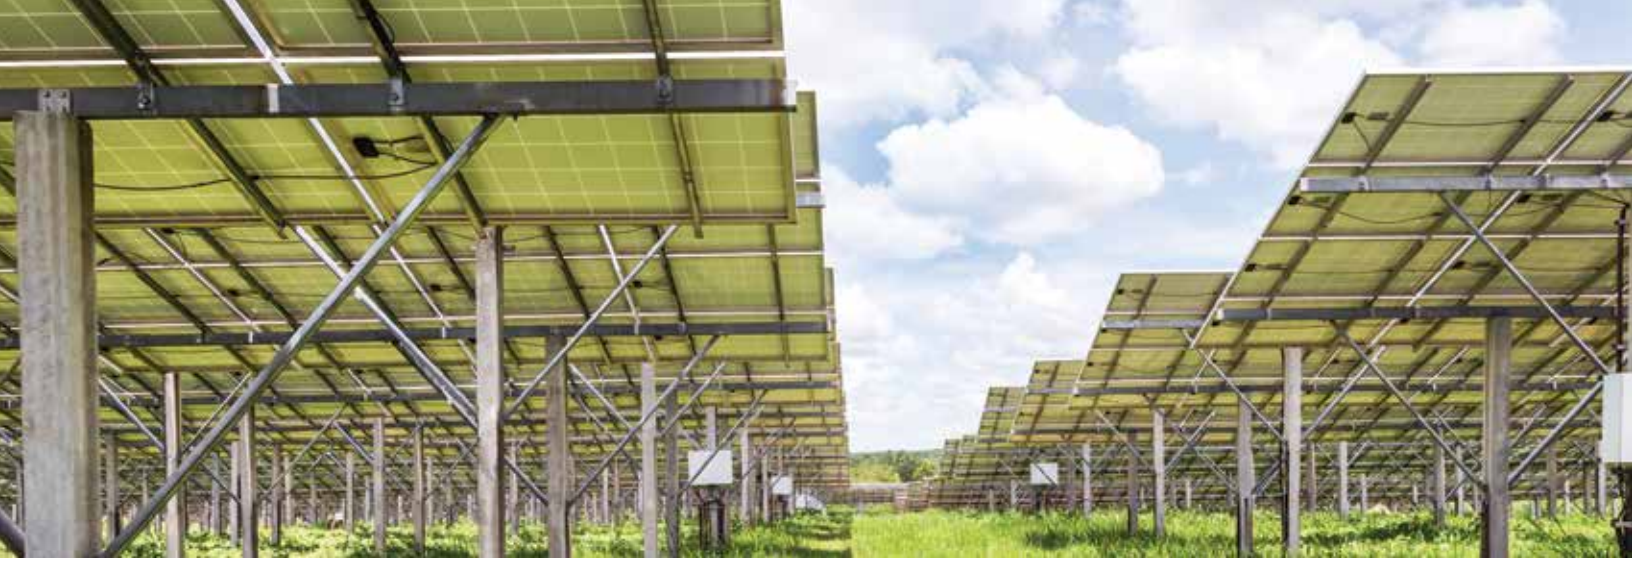
PET backsheet failures

Inner- and outer-layer cracking

- Inner-layer cracks enable moisture to enter, often leading to busbar corrosion
- Outer-layer cracking exposes PET core to environmental degradation, also allowing moisture to enter
- Exposing module interiors to moisture can lead to shorting, inverter trips, power loss, and multiple module fires

Inner-layer cracking

7 years, Sonoran Desert, Arizona, USA

Outer -layer cracking

8 years, Arizona, USA

Outer-layer cracking

6 years, NW China

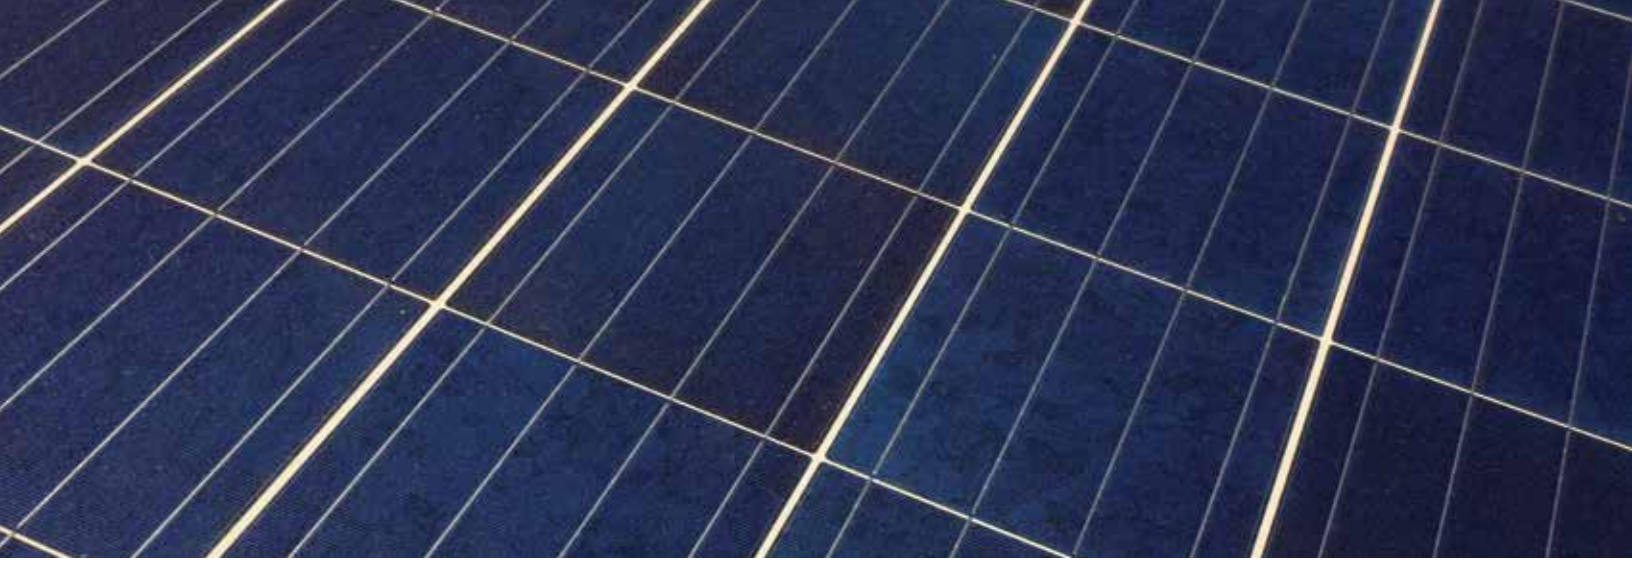
Glass – glass module failures

Delamination and cracking

- Delamination appears to originate near edges of a module or at individual cells
- Cracks likely originate at scratches or chips on the glass surfaces and edges or at stress risers introduced by the racking system

Glass/encapsulant delamination
1.5 years, Northern China

Encapsulant delamination
10 years, Arizona, USA

Delamination and corrosion
15 years, Southern China

Delamination
20+ years, Italy

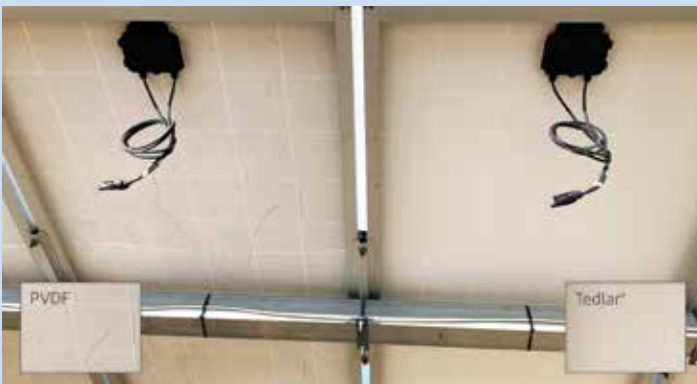
A large independent power producer (IPP) in Arizona discovered one of their sites was producing less energy than predicted. Upon reviewing the system for failures, they found certain backsheets had started to crack and delaminate – leading to high leakage currents tripping inverters and causing partial shutdowns and late starts.

DuPont inspected the 7-year-old site through its Fielded Module Inspection Program and discovered widespread backsheet cracking and delamination on many of the modules. While the site was composed of modules from a single manufacturer and model, as many as three different backsheet types were identified, suggesting the module manufacturer used multiple bills of materials (BoMs) for the same project.

- **100% of PA backsheets exhibited cracking along busbar ribbons**
- **100% of PET backsheets exhibited inner-layer cracking**
- **100% of PVDF backsheets exhibited outer-layer cracking**
- **0 defects in Tedlar® PVF backsheets**
