DuPont global PV reliability

2019 Field analysis

Executive summary

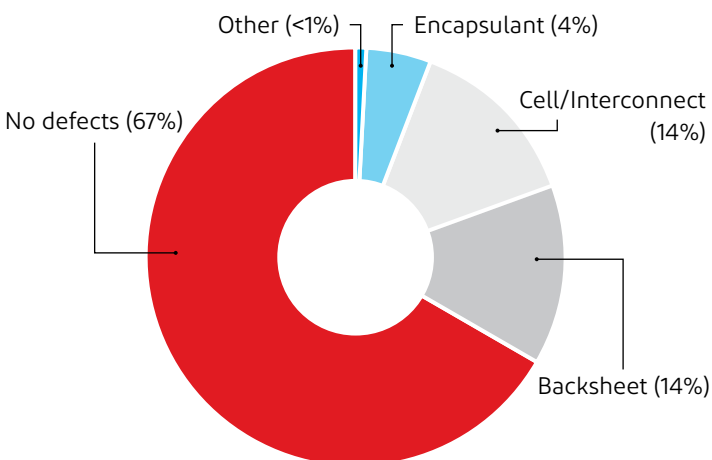
Module defect trends

While there were no defects in the majority of module materials, the following defects were observed at certain levels:

- Cell/Interconnect – corrosion, hot spot, snail trails, broken interconnect, cracks, burn marks
- Backsheet – outer-layer (air side) and inner-layer (cell side) cracking, delamination, yellowing
- Encapsulant – discoloration, browning, delamination
- Other – glass defects, loss of AR coating, junction box

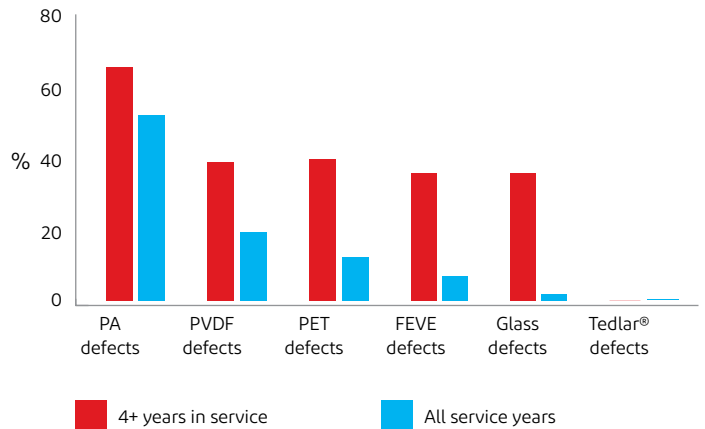
Backsheet defects by panel age

There was a sharp increase in backsheet defects after 4 years for competing module materials, yet Tedlar® defects stayed at a low 0.04%.

Sharp increase in backsheet defects after 4 years

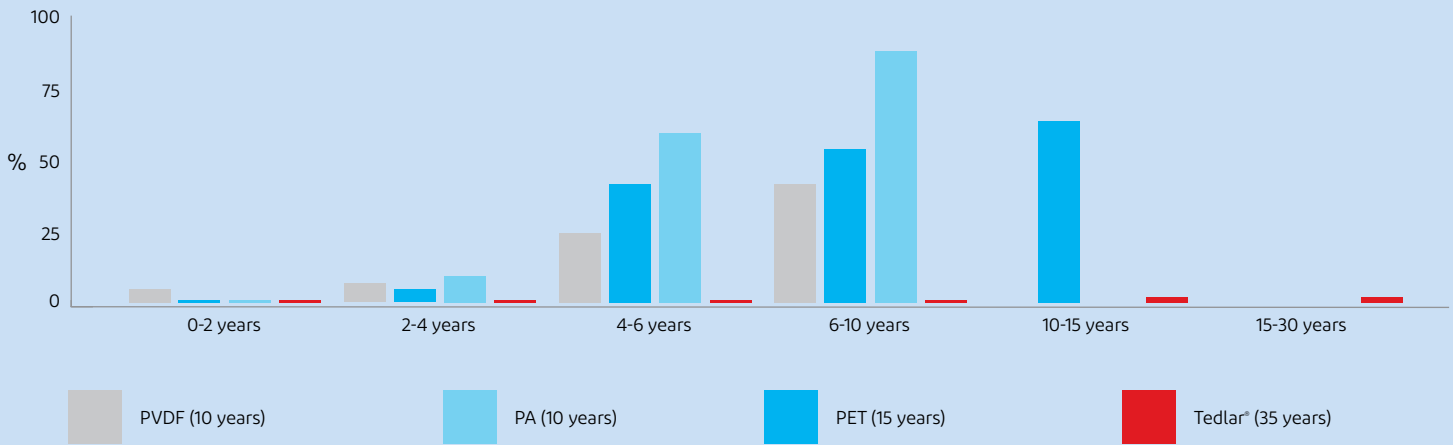
In fact, Tedlar® PVF film-based backsheet maintains the lowest defect rates – even after 35 years in the field.

Only Tedlar® PVF maintains lowest defect rates after 30+ years

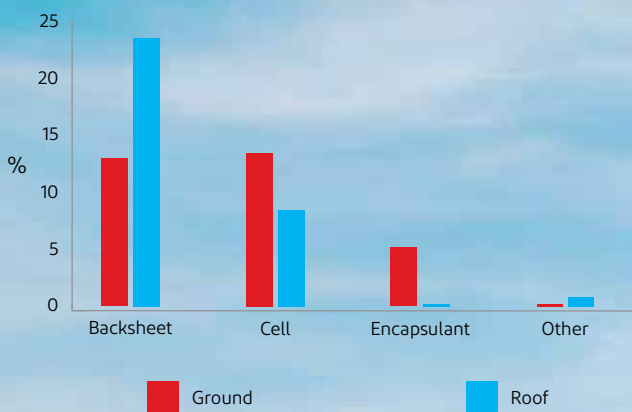
Backsheet defects by temperature

Higher temperatures cause backsheet defects to accelerate. These rates are 75% greater for roof installations than ground, as roof-mounted systems typically run 15 °C higher than ground-mounted.¹

Higher temperatures accelerate backsheet defects
