# **Tedlar<sup>®</sup>** protective film for Interiors in Healthcare Environment

October 2020

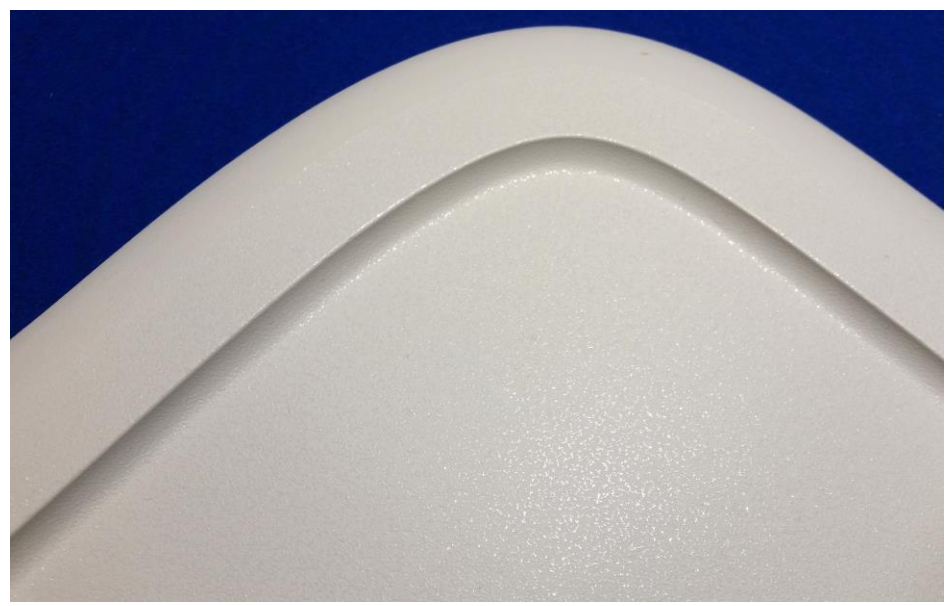
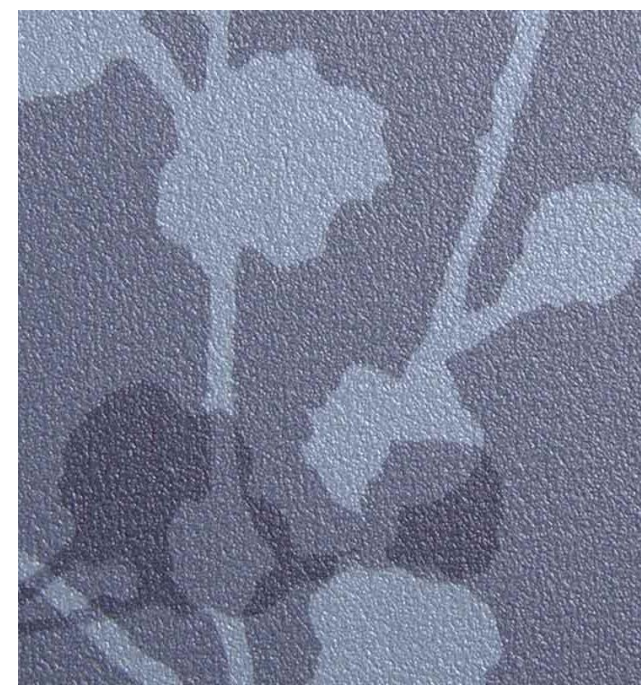
# Example - Product Formation with Tedlar® PVF Film

**Finished part  
protected with  
Tedlar® PVF Film**

**Lamination**

**Embossing**

**Lamination to substrate,  
thermoforming or  
vacuum forming**

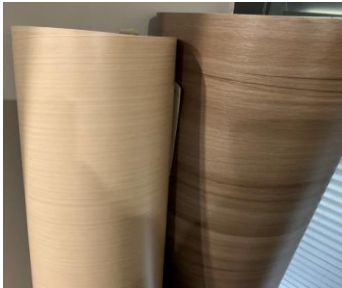
Examples: *PVF film laminated onto:*

PVC

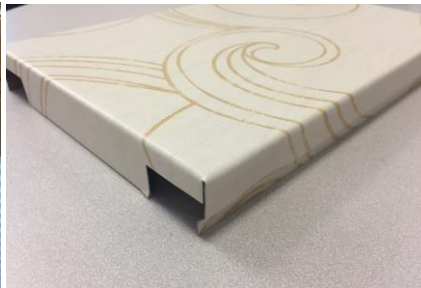
Metal

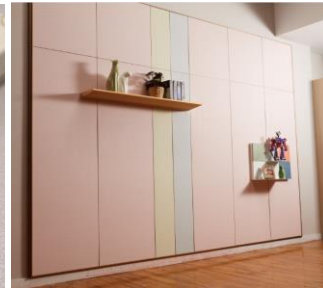
Wood or plasterboard

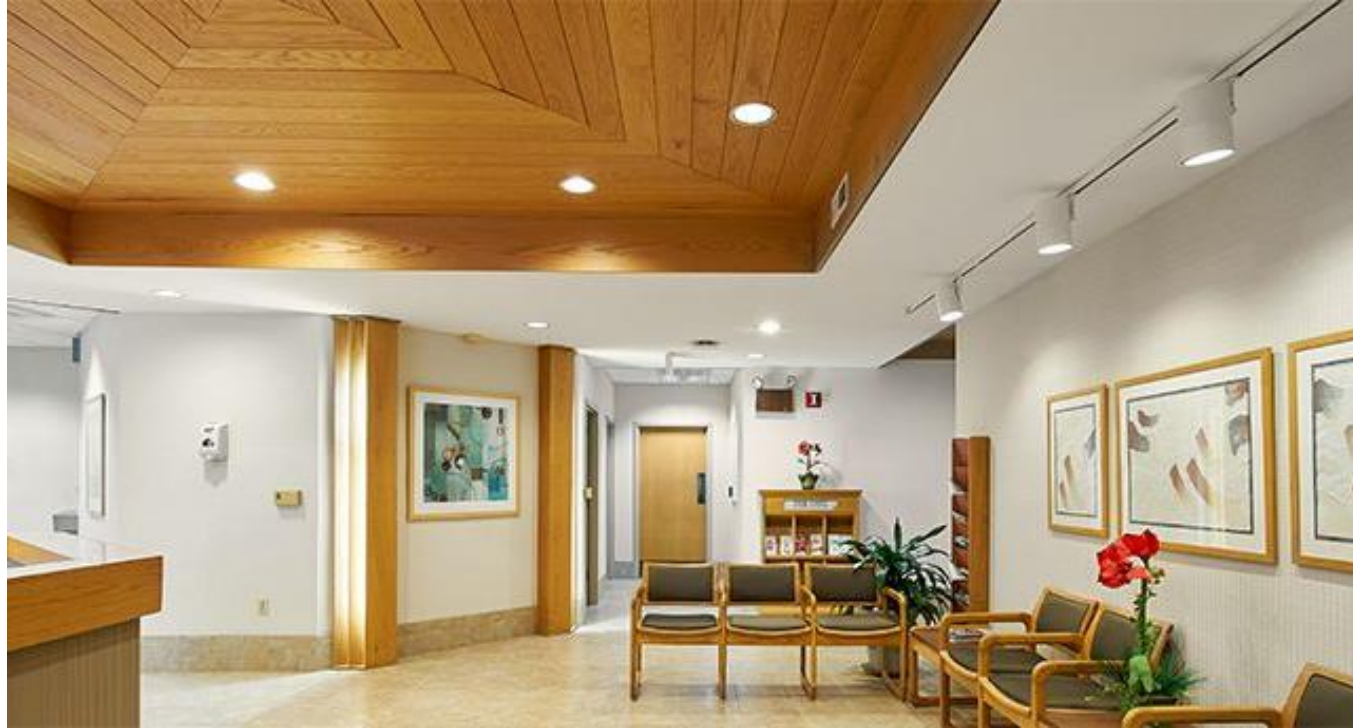
Still going strong: Tedlar® protected wallcoverings are delivering durability and style for 30+ years

Omega Medical Center in Delaware region, built in 1985.

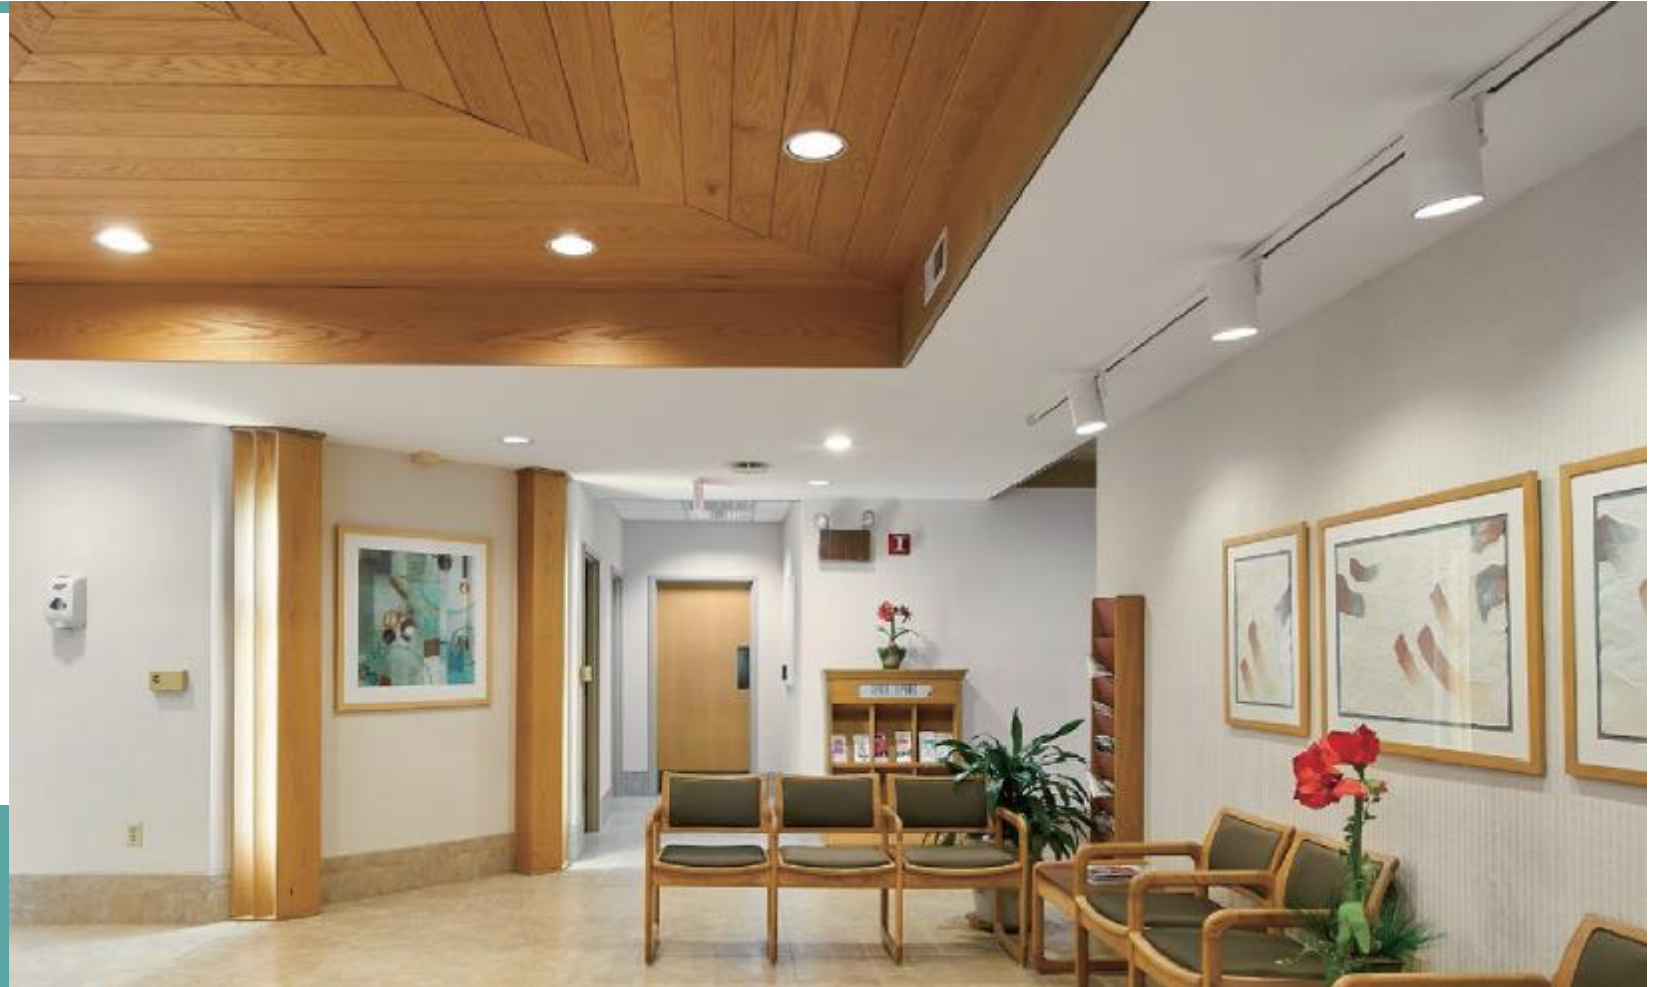
Tedlar® PVF Interior Surface perfectly combine **Tedlar® wallcoverings' superior functionalities and durable metal board** that enables enduring style and extreme cleanliness. The **modular parts** with installation steps to meet all the requirements for the healthcare environment construction.

Application area: patient room, public area, waiting area.

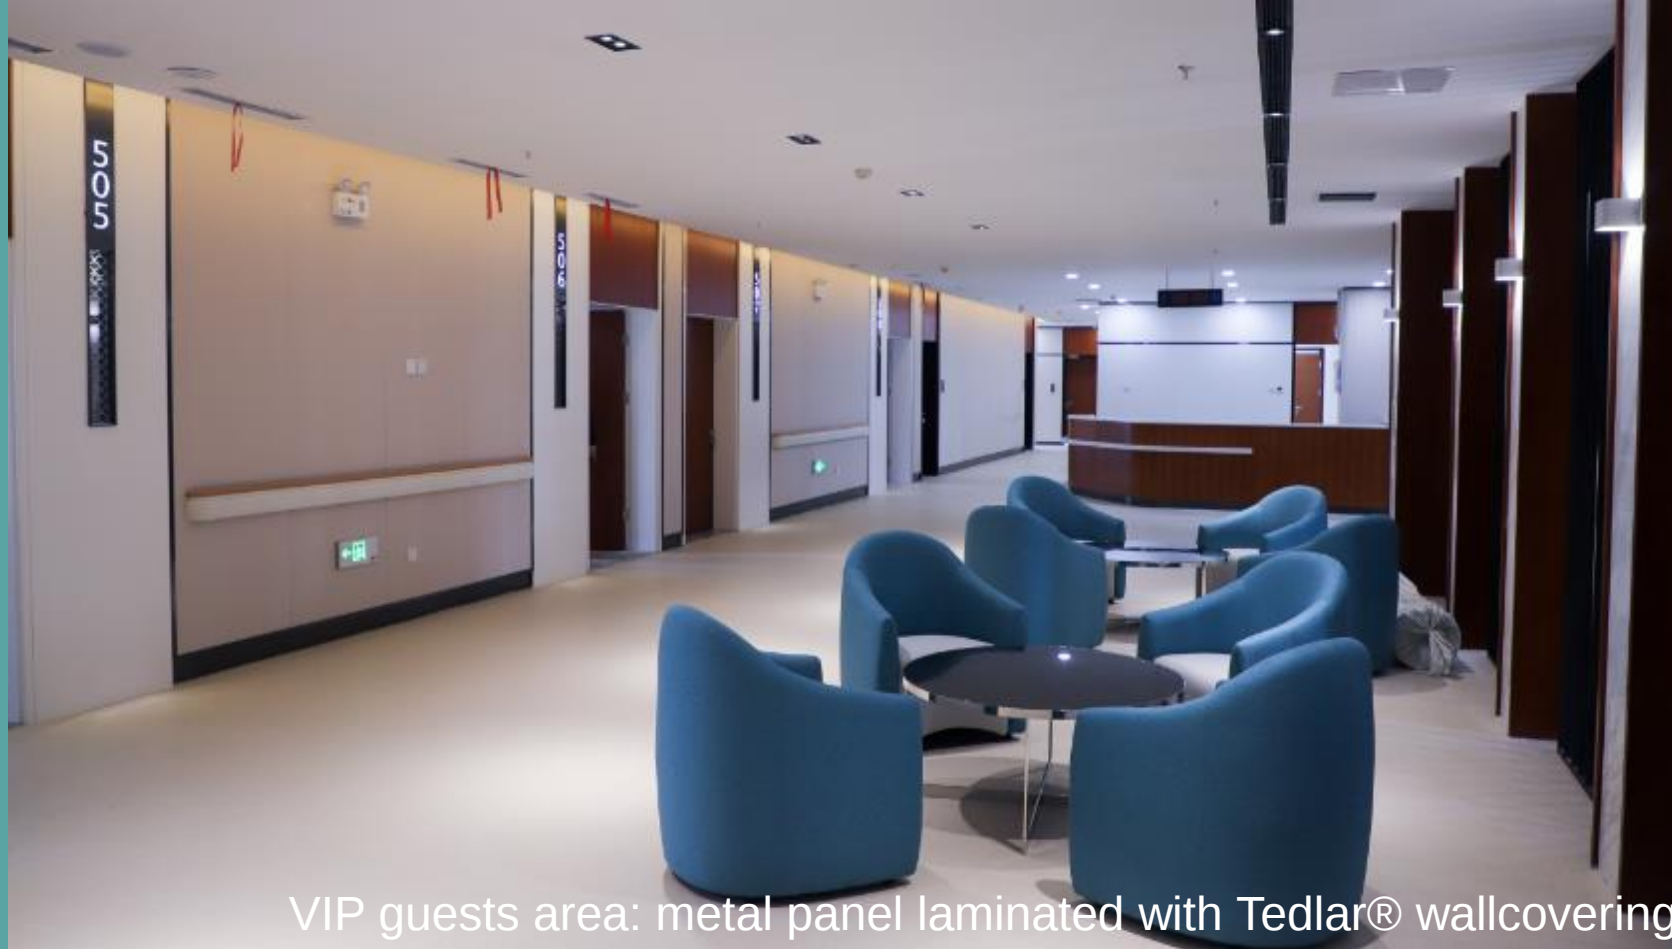
VIP guests area: metal panel laminated with Tedlar® wallcovering

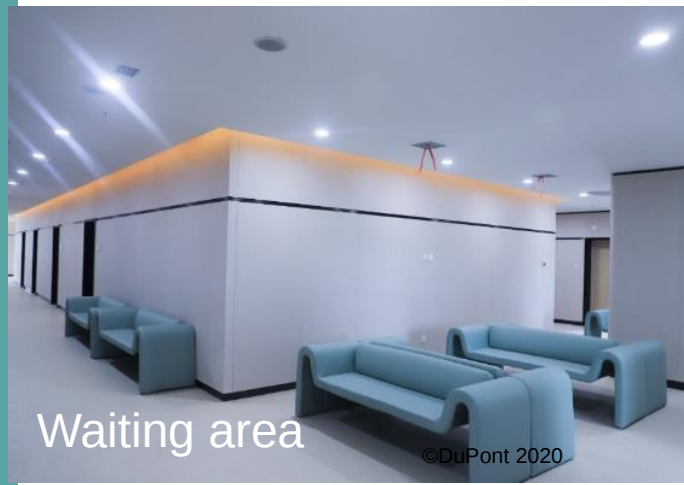
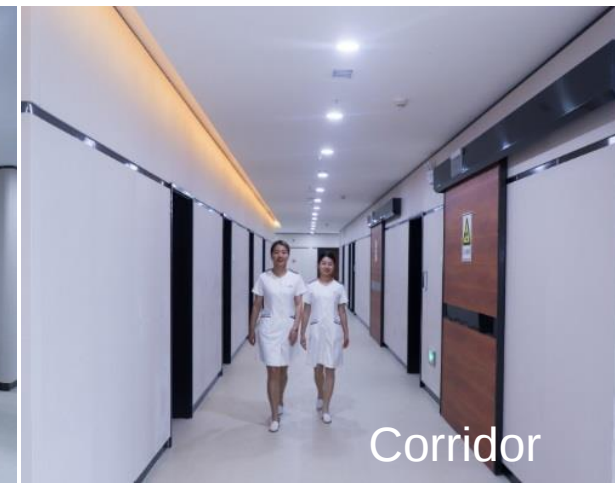
Waiting area

Corridor

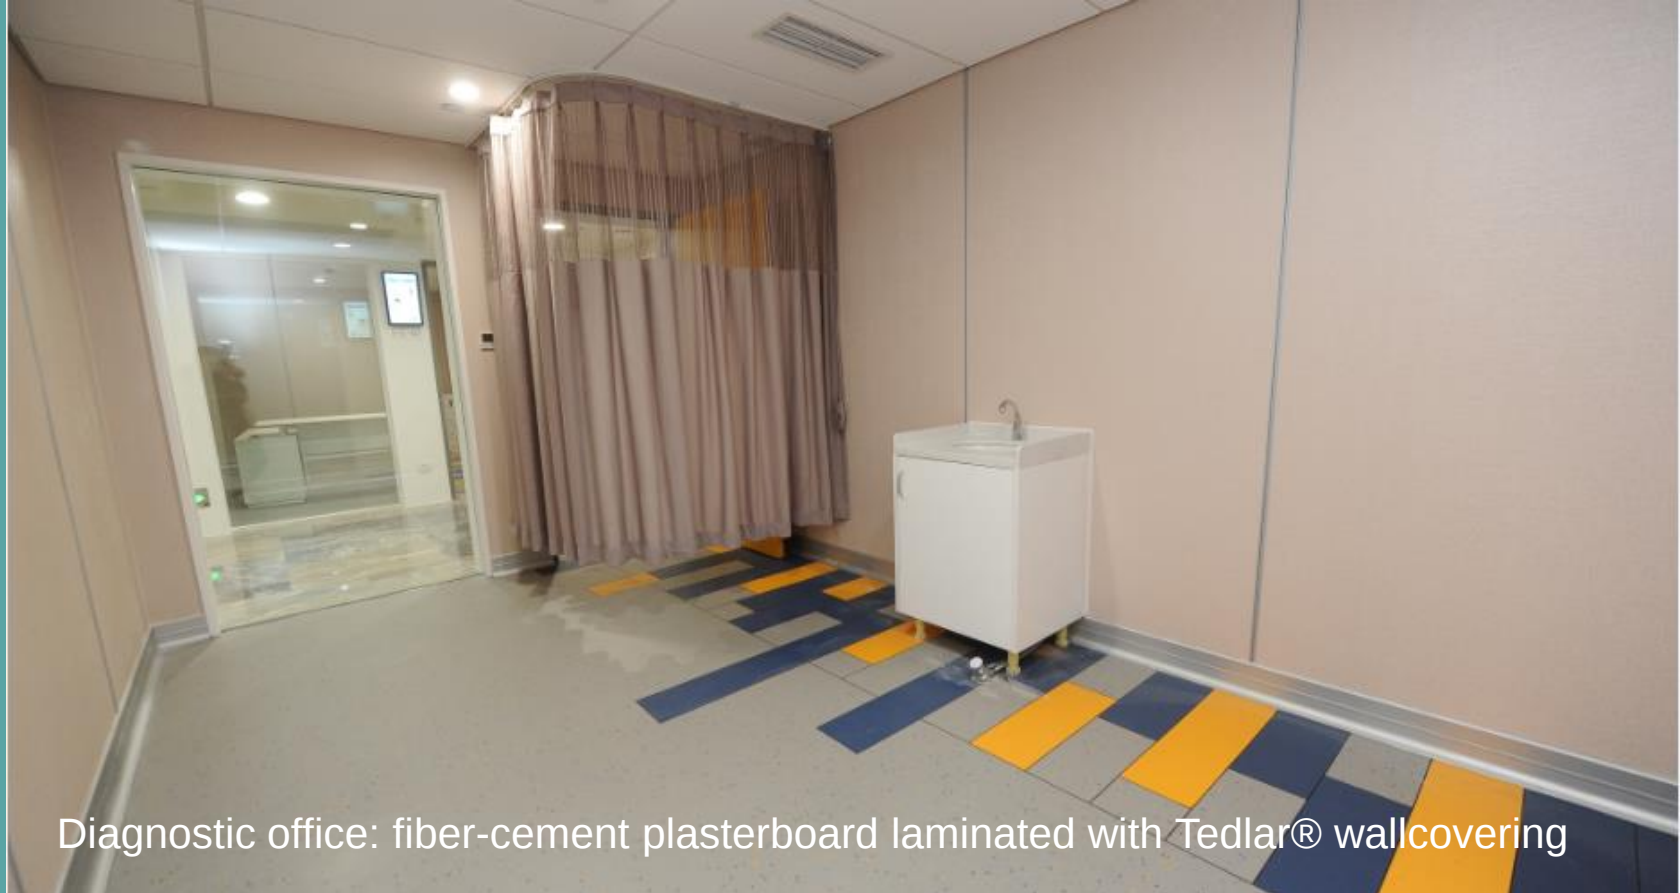
Diagnostic office: fiber-cement plasterboard laminated with Tedlar® wallcovering

Modern healthcare environment creation for a private maternity hospital. Over 30,000 sqm Tedlar® wallcoverings laminated on fiber cement board pre-installed, covering doctor's office, corridor, VIP patient room and labor room.

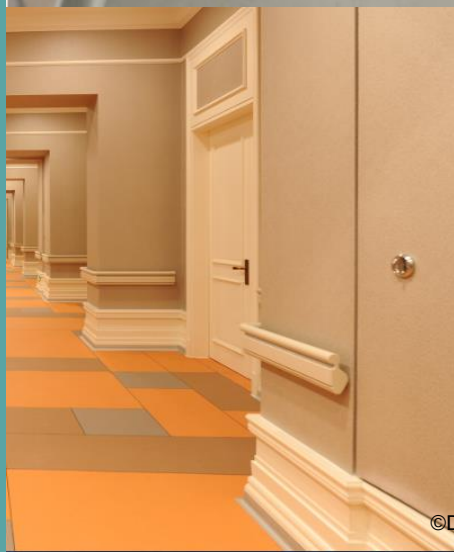
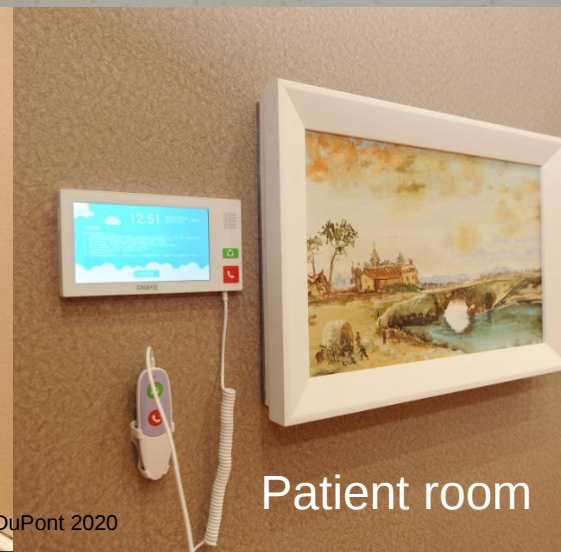
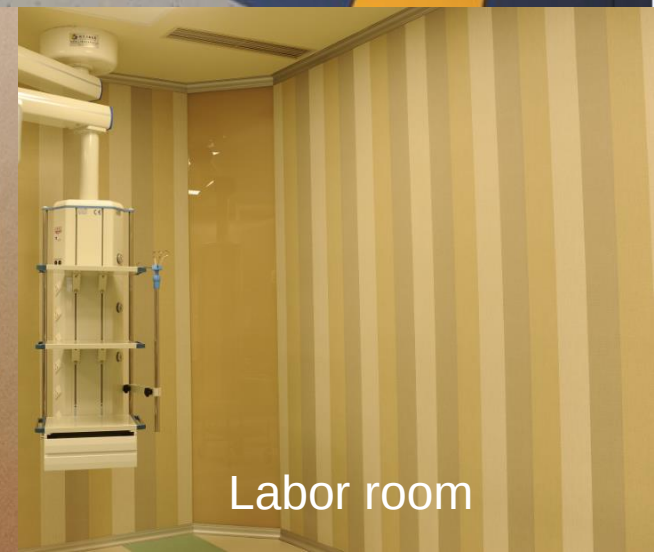
Patient room

Labor room

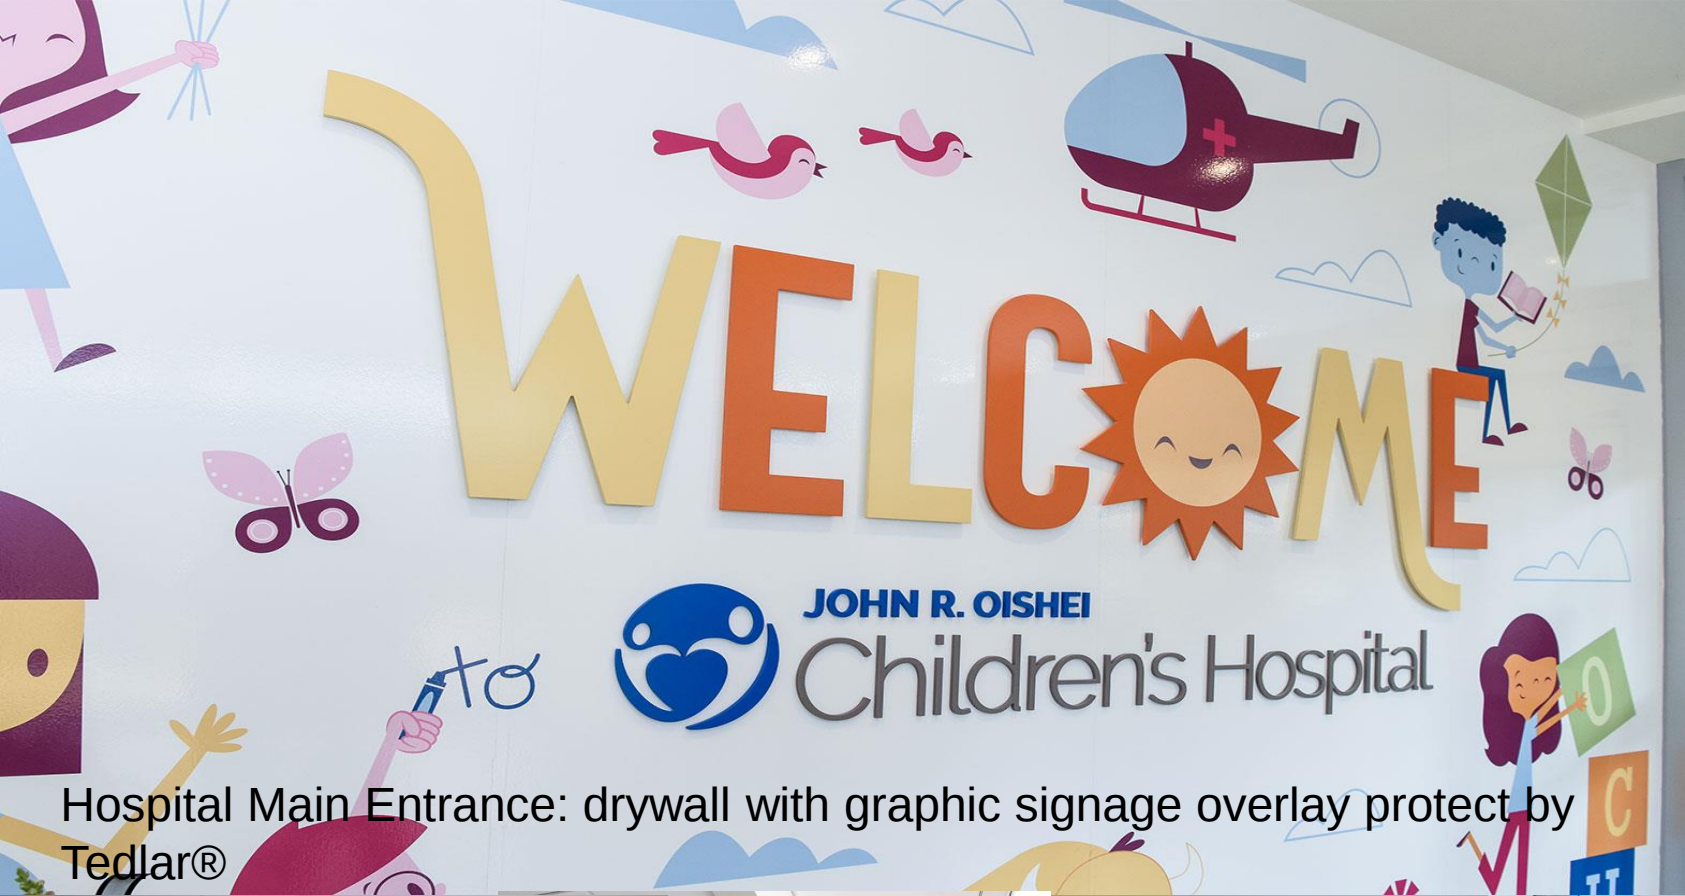
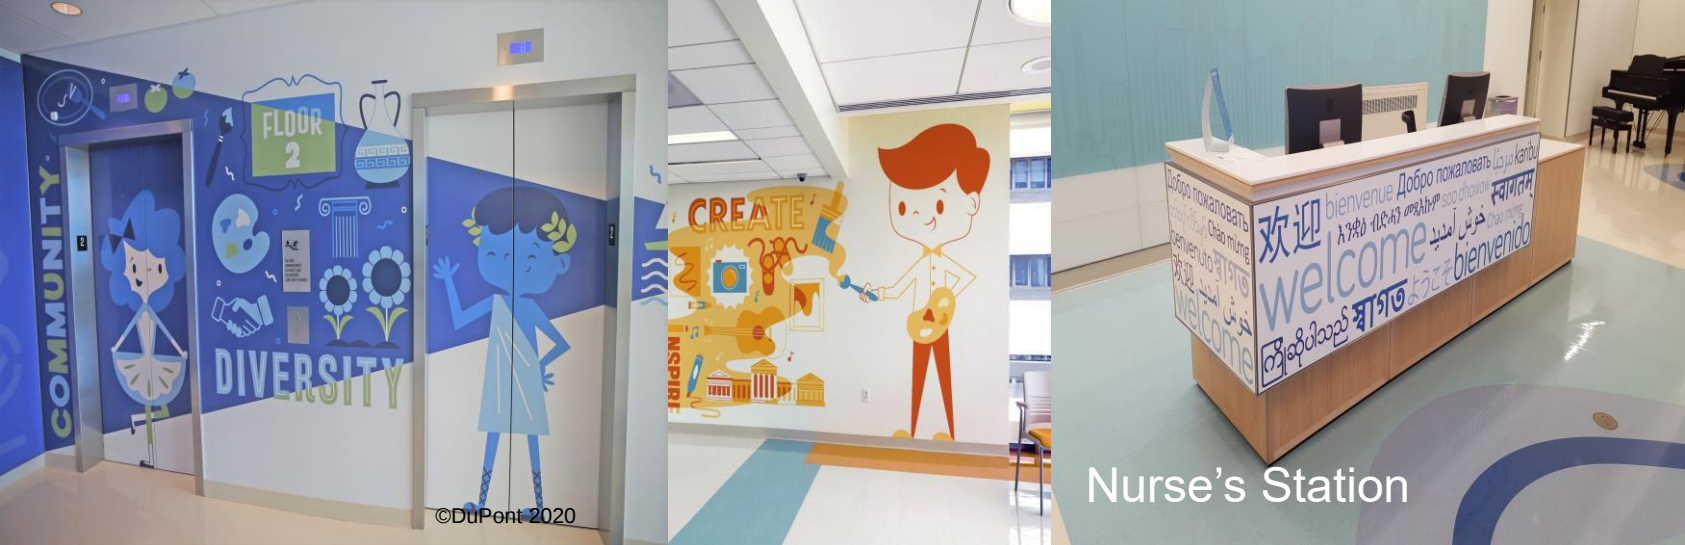
John R. Oishei Children’s Hospital, Buffalo, New York

Tedlar® is often used in applications that see high human traffic, such as the art installations in patient areas at Buffalo Children’s Hospital in New York. In 2018, many of the common areas of the hospital were redesigned to include inspiring graphics for children and their families.
